GREAT NOTCH RESERVOIR NJ 00244

PHASE 1 INSPECTION REPORT NATIONAL DAM SAFETY PROGRAM

> Great Notch Reservoir (NJ 00244). Passaic River Basin, Yantecaw Brook, Passaic County, New Jersey. Phase 1 Inspection Report.

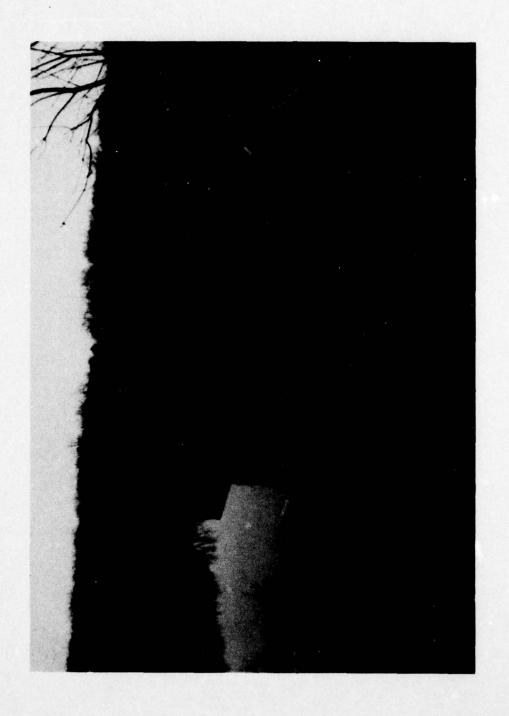
GREAT NOTCH DAM View eastward from right abutment. (December 2, 1978)

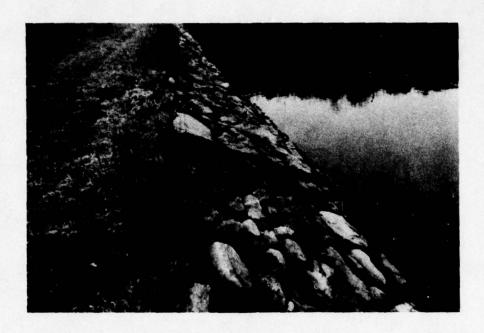
The dam was inspected for signs of settlement, seepage, erosion, cracking and any other evidence of undesirable behavior which might affect the stability of the structure. There were no discernable vertical or horizontal misalignments of the crest (see Overview Photo). The exposed riprap above the waterline appears to be in good condition (Photo 1).

Photo 1 - Rock riprap extends to the crest of the embankment. (12-2-78)

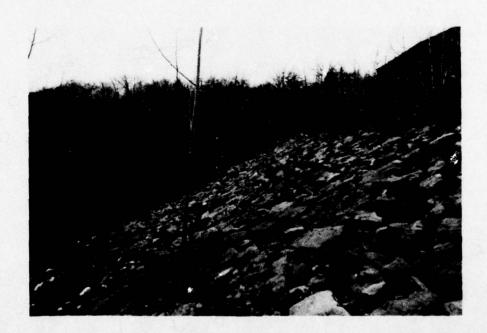
Rock facing covers the entire downstream slope of the dam. The rock above the bench in the embankment appears to be carefully hand-placed (Photo 2), while that below the bench is randomly dumped (Photo 3). A small rock slide, about 20 by 50 feet, was observed on the lower right side of the embankment (Photo 4). Small trees have grown in this area. The growth of trees is a general problem on the downstream embankment, but it is particularly acute along the embankment bench (Photo 5). Overall, the downstream side of the dam appears to have a reasonably even slope, with only minor swales and little erosion.

Photo 2 - Hand-placed rock facing above the downstream embankment bench. (12-2-78)

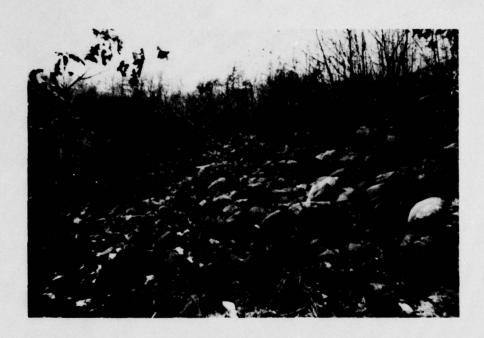
Photo 3 - Dumped rock fill facing below the downstream embankment bench. (12-2-78)

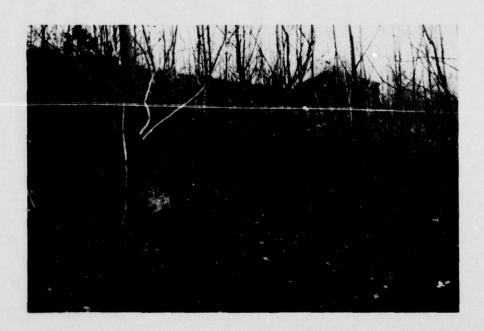
Photo 4 - Rock facing denuded by a slide on lower right side of downstream embankment. (12-2-78)

- (3) Operate all valves on a regular basis.
 - (4) Replace dislodged rocks on the embankment facing.
 - (5) Regularly inspect the dam and record all maintenance work.

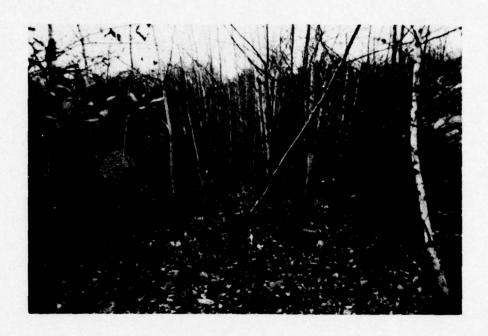
Photo 5 - Heavy growth of trees along downstream embankment bench. (12-2-78)

- Regularly operate all valves at the intake structure and outlet works.
- Remove all trees and brush from the face and crest of the dam and from the spillway channel.
- 3. Replace dislodged rock facing on the downstream embankment.
- Regularly inspect the dam and keep records of all maintenance work.
- Install survey monuments on the crest and downstream embankment and periodically make settlement surveys.
- 6. A contingency plan and an emergency warning system should be established to provide adequate warning to downstream residents. Also, surveillance of the dam should be provided during periods of heavy precipitation.

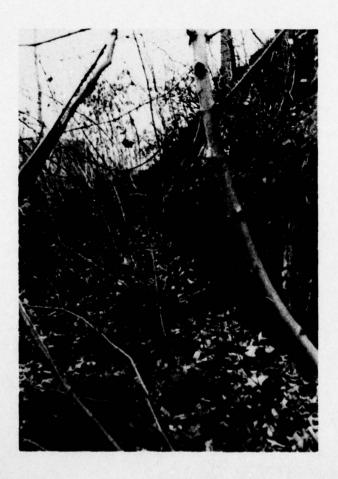
The abutments on each side of the dam were examined for any indications of apparent instability or seepage. On the left abutment, near the top of the dam, there is a small drainage channel cut into the hillside. About 5 gpm of seepage was observed in this channel but at an elevation higher than the reservoir level. Downstream abutments on both sides of the dam are exposed quartzite bedrock. The embankment-abutment contacts appear to be sound. A rock ledge on the lower left abutment separates the natural spillway channel from the dam embankment (Photo 6).

Photo 6 - Rock ledge on lower left abutment separating dam embankment (left) from the spillway channel (to right of photo). (12-2-78)

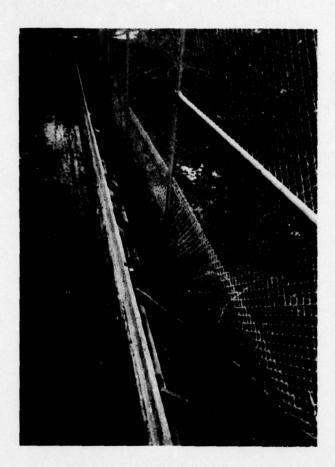
The hydrologic and hydraulic analyses indicate that the spillway, with flashboards in place as they presently are, is seriously inadequate because it can pass only about 35 percent of the Probable Maximum Flood (PMF). If the flashboards were removed, the spillway could pass about 65 percent of the PMF and the spillway would thus be classified as inadequate, not seriously inadequate.

The spillway crest has wooden flashboards installed on top of it (Photo 7). The concrete sill and stone masonry training walls appeared to be in satisfactory condition. Immediately downstream there is a chain-link fence installed for security purposes (Photos 7 and 8). This fence could catch floating debris and seriously impede flow through the spillway in the event of flood.

With 15-inches of flashboards in place, all floods greater than about 35 percent of the PMF, when routed through the reservoir, will overtop the dam. The PMF will overtop the dam for about 4.0 hours and have a maximum stage about 1.0 foot above the top of dam. One-half the PMF will overtop the dam for about 1.3 hours and will have a maximum stage about 0.3 feet above the dam crest. These overtopping heights assume the dam remains in its current condition. A dam breach analysis was made to determine if the existing spillway is Seriously Inadequate because (1) the Spillway Design Flood is the PMF; (2) the spillway is not capable of passing one-half the PMF; and (3) there is a high downstream hazard to loss of life. The results of this analysis are presented in Section 5.1-a. One of the

Photo 7 - Spillway crest and installed flashboards.
(12-2-78)

It is recommended that the spillway flashboards and downstream security fence be removed very soon. Other recommendations are of a less urgent nature and should be implemented in the near future. These include determination of the source of seepage in the spillway channel and taking remedial measures as needed, investigation of alternative methods of draining the reservoir, regular operation of all valves, removal of vegetation on the embankment, replacement of rock facing on the embankment, regular inspection of the dam, installation of survey monuments and piezometers on the downstream embankment to monitor phreatic surface.

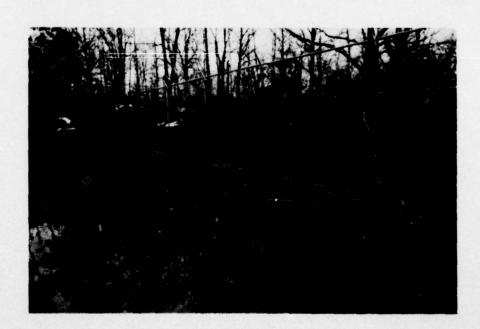
Photo 8 - Spillway, looking toward left abutment. Note close proximity of downstream chain-link fence. (12-2-78)

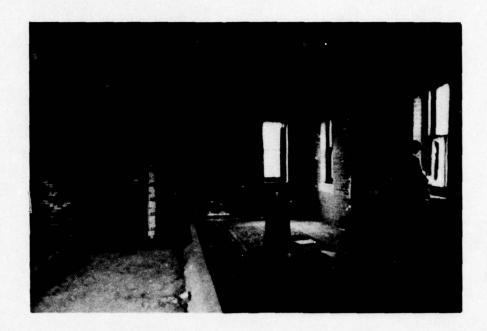
The observable structures of the outlet works include the gate house at the top of the dam and the twin tunnels at the downstream toe of the dam housing the force main and the distribution main. The gate house itself is in reasonably good condition, although vandals have broken the windows of the building. Inside the building, most of the gate controls appear not to have been operated for some time (Photo 9). The owner's representatives reported that 2 of the controls were operated in recent years but the remaining have not been operated in more than 20 years. The valve controlling the 48-inch outlet pipe has not been closed for many years, since it is feared that it cannot be reopened.

Most of the valves have not been operated in many years and are thus in questionable operating condition.

Photo 9 - Inside of gate house, showing gate controls, staff gage and float gage. (12-2-78)

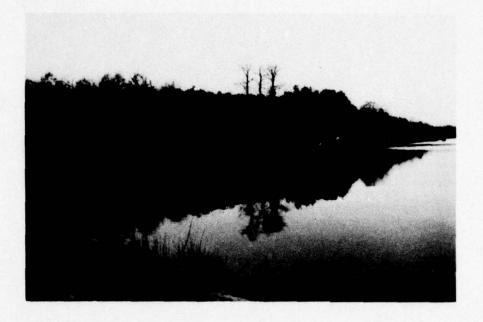
Photo 11 - Right bank of reservoir looking northwest from the dam. (12-2-78)

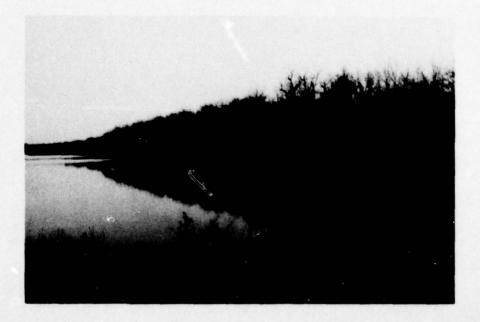
Photo 12 - Left bank of reservoir looking northeast from the dam. (12-2-78)
